# 2004 Cadillac XLR: Service Information: HVAC Module Service

This information applies to the 2004 Cadillac XLR and the 2005 Chevrolet Corvette and newer.

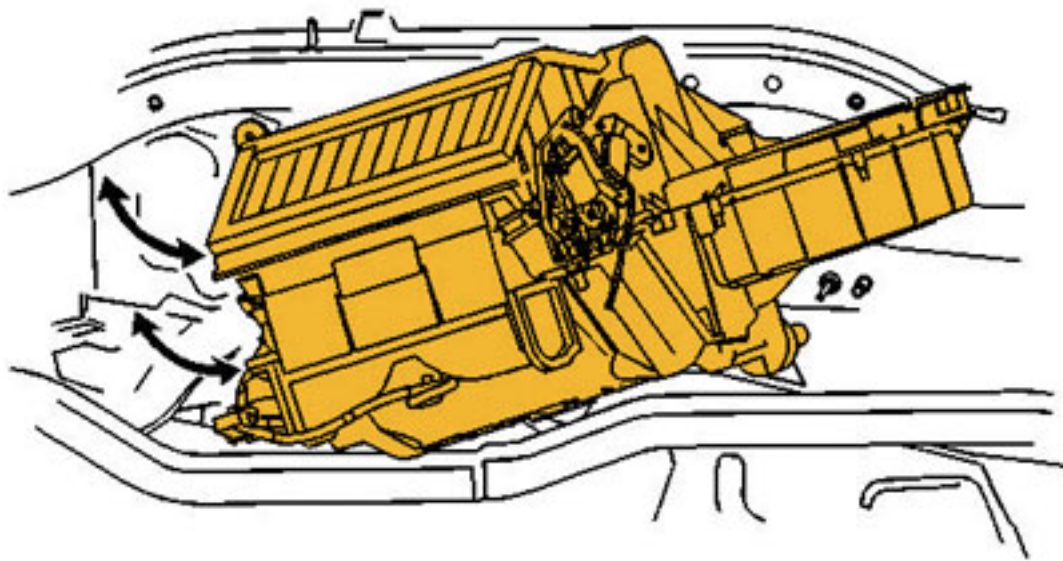
(fig. 11 - attached). The HVAC module must be partially disassembled before removal and installation (fig. 12 - attached).

Refer to SI 2000 to obtain the service procedure for correctly removing and installing the HVAC module. Failure to do could result in damage to the HVAC module.
